Christ Church Cathedral Dublin

CONSERVATION MANAGEMENT PLAN

JUNE 2023

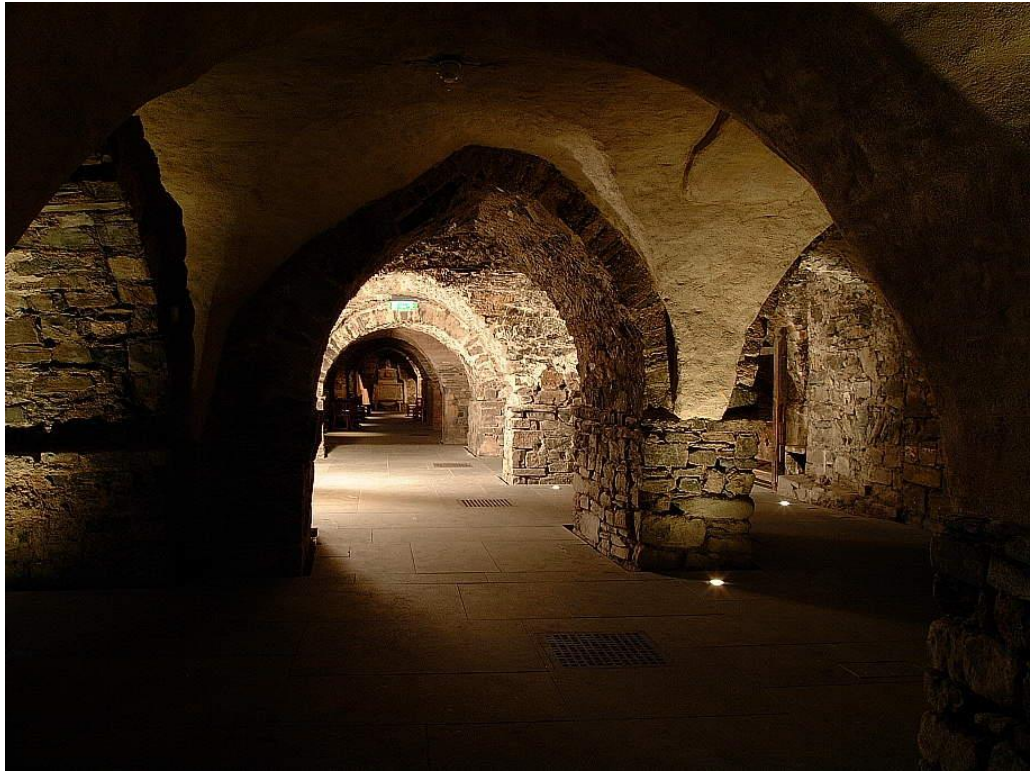
View in the 12th century crypt which extends under almost the entire cathedral

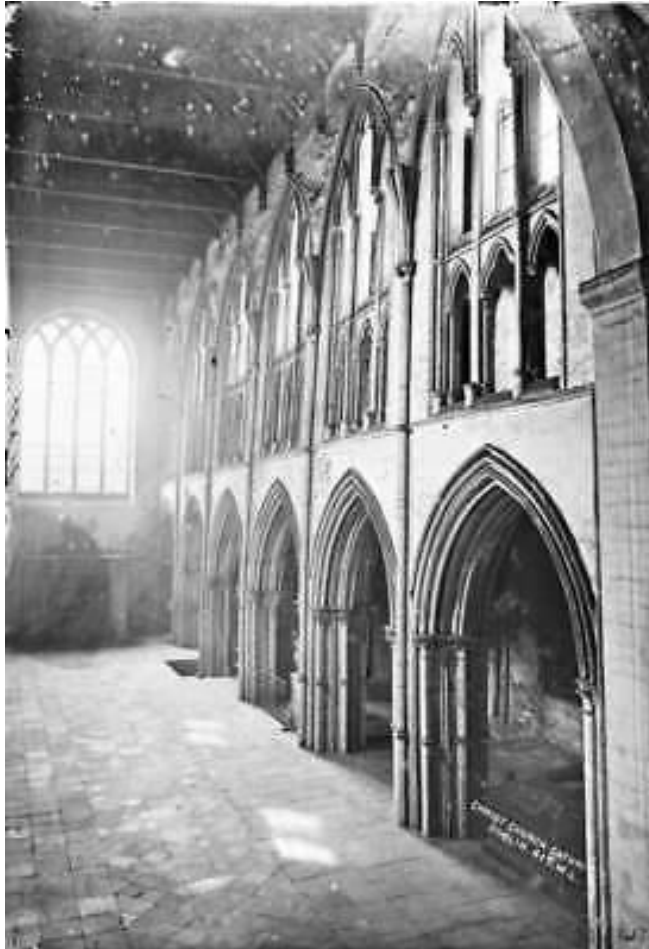
Nave c. 1870 prior to Street's restoration showing the exposed roof and submerged bases to the piers

There is no doubt that the nave of Christ Church is the finest piece of mid thirteenth-century Gothic architecture in Ireland. Of course only the north elevation is medieval, the rest dates to Street's 1870s restoration. Photographs by Miller & Robinson before the Street restoration, show that Street made only minor changes – regularising all the rebuilt pier's attached shafts to have annulets at half height and replacing worn

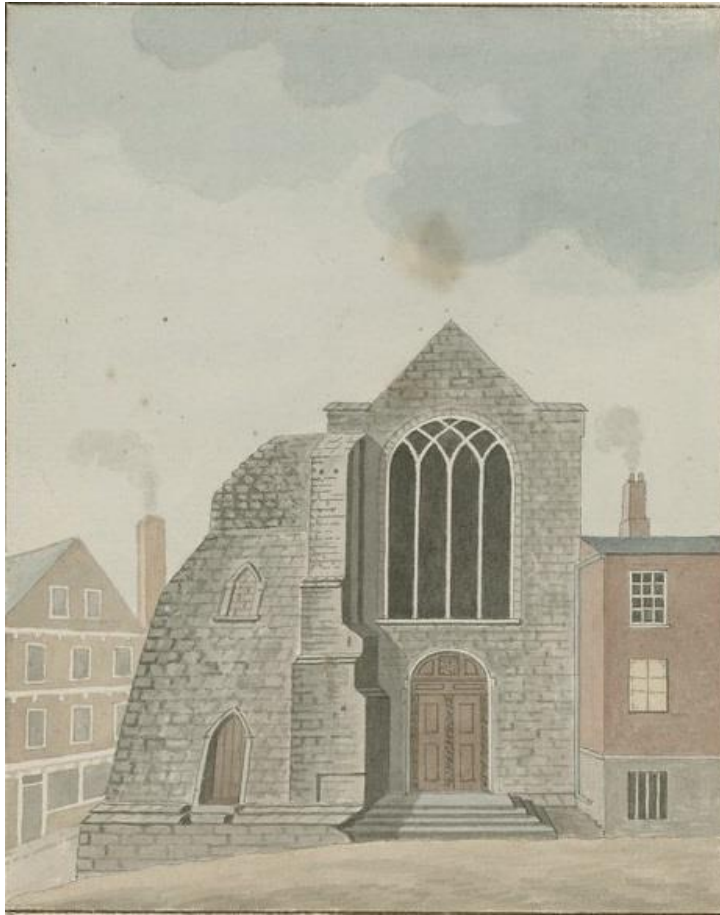
West front by Gabriel Beranger showing buttress to gable

One of the recurring issues in the 18th century was the stabilisation of the cathedral after the 1562 nave collapse, mostly involving the stability of the north and west walls of the nave. By 1744 the surveyor general, Arthur Jones Nevill, was assigned to restoration work at the Four Courts, and in 1745, the chapter specifically ordered 'the West End of this Church to be Propt [propped], and when done that the same be pulled down, in order to be rebuilt, and that Mr Nevil Jones be applied to for a Plan for the same'.

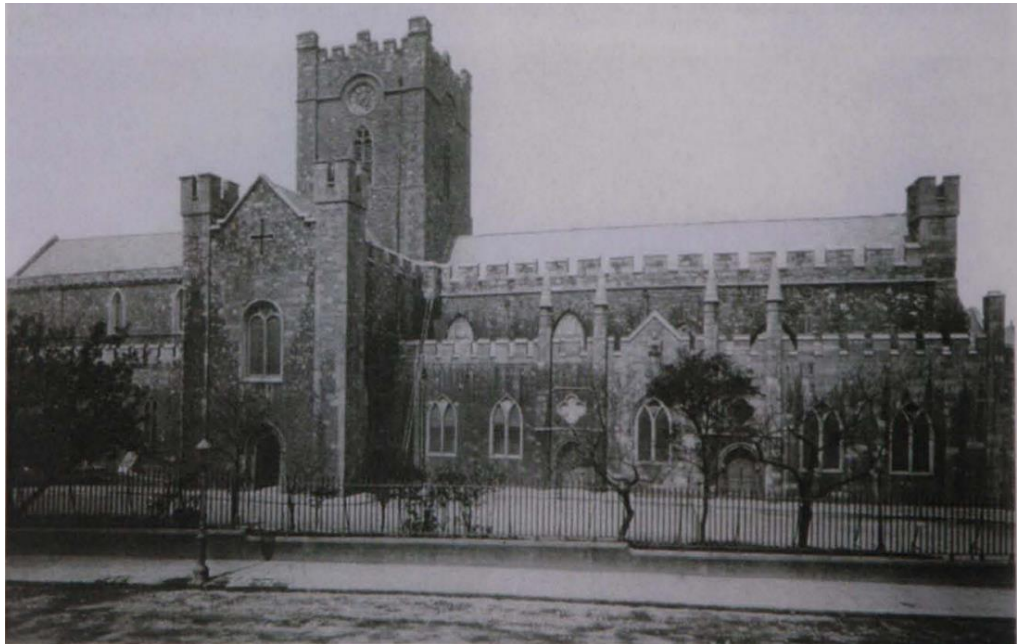
South facade of cathedral pre 1870 showing Mathew Price's work to the tower, transept and long choir

The restoration of the cathedral by the little-known architect, Matthew Price, who was appointed in 1829, was almost universally reviled by numerous mid-19th century commentators. In the choir in 1831-3 he removed the classical galleries and installed Georgian gothic plaster surrounds to the arches and windows. Externally, he added turrets to the transepts and generally tidied up the facades in the half-hearted gothic style of the time. A redeeming factor was his retention of the Romanesque doorway which was removed from the north side of the cathedral to the south side. Similarly, the 'Roman window' in the south transept seems to have been reused from elsewhere, namely the old Lady chapel which he converted to administrative uses. The second phase of the restoration was not carried out until 1844-6, when Price restored the tower and nave. The tower was given circular clock faces with string courses curving over them, new bells were cast by local bell founders, Murphy's on James's Street and a clock was installed by Maxwell McMaster and Son and W McMaster Junior. The latter still survives but is not visible on the exterior of the tower.
